AUTOMATIC TRANSMISSION

CONTENTS

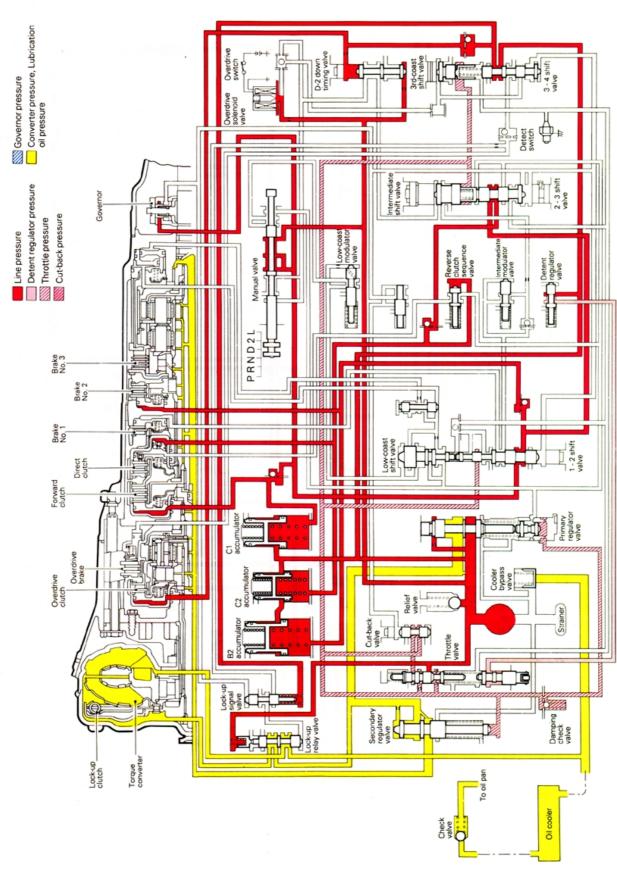
D-3 (DRIVE 3RD)

Governor pressure
Converter pressure, Lubrication oil pressure Line pressure

Detent regulator pressure Cut-back pressure Throttle pressure PRND2 Brake No. 3 Brake No. 2 Brake No. 1 Direct Forward Overdrive brake Overdrive Lock-up clutch Torque

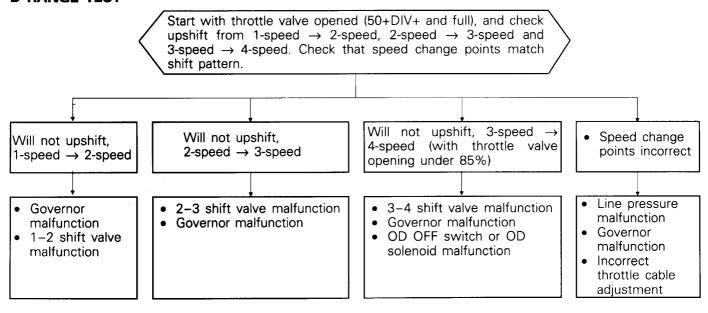
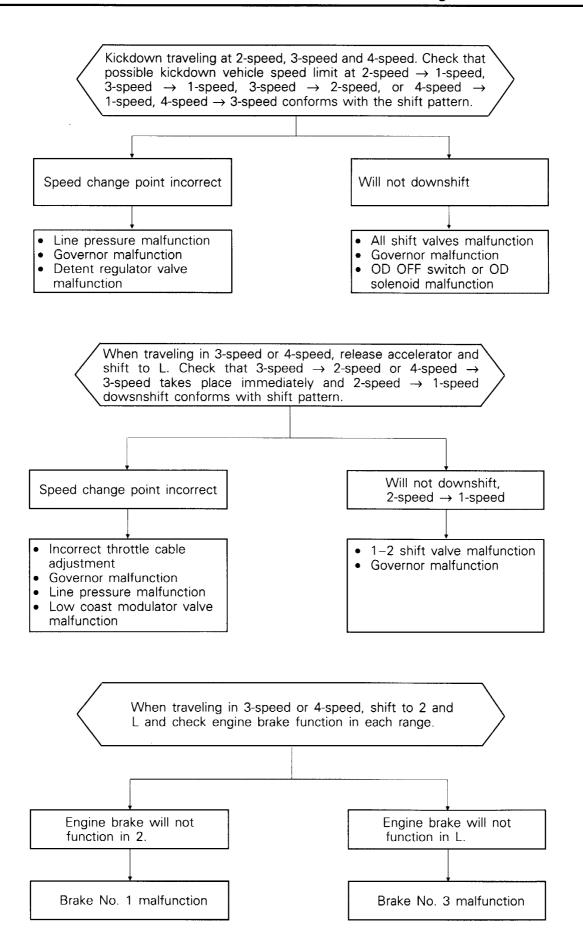
D RANGE TEST

Prior to performing road test, be sure to make basic checks including check and adjustment of fluid level and condition and adjustment of the throttle cable. For road test, the transfer must be placed in the 2H (2WD-high) position. In road test, various changes such as slips in transmission and shifting conditions are checked and hence the transmission operation at each shift position must have been checked.

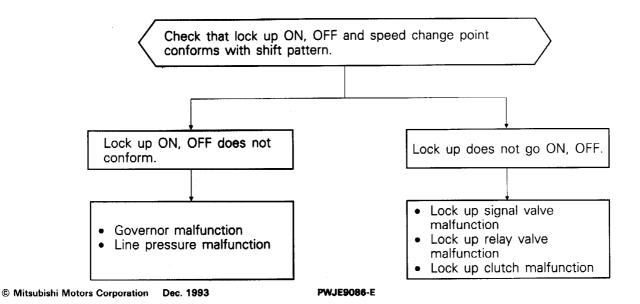
- (1) Determine the moment when lock up turns ON by decreased engine r/min or by a slight shock back and forth.
- (2) Determine the moment when lock up turns OFF by increased engine r/min.
- (3) Check lock up condition by pumping the accelerator slightly. If engine r/min rises in accordance with throttle valve opening size, determine that the lock up is OFF, if not, determine it ON.
 - When lock up is OFF, drive power is transferred through the fluid in the torque converter and therefore, when the accelerator pedal is depressed, slipping occurs inside the torque converter with a resulting large increase in engine r/min.

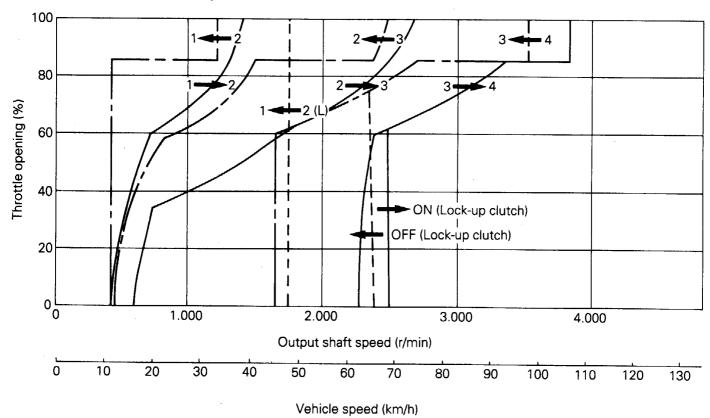
2500D < V4AW2-3-QGP, QGPL>

SHIFT PATTERN

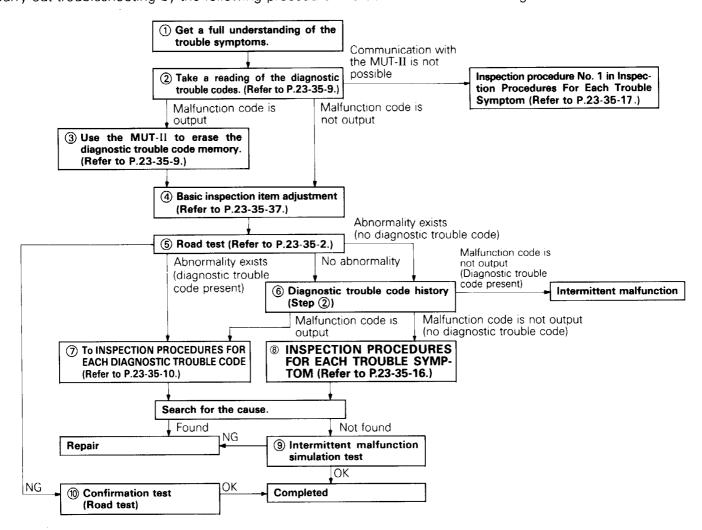
STANDARD FLOW OF DIAGNOSTIC TROUBLESHOOTING

Malfunctions of the 4 A/T system can be caused by malfunctions or incorrect adjustments of the electronic control system, hydraulic control system or A/T system or a combination of these. Carry out troubleshooting by the following procedure in order to make effective diagnoses.

- ① Gain a full understanding of the conditions under which the trouble symptoms that the customer is complaining about occur, including frequency of occurrence.
- ② Use the MUT-II to read and make a note of the diagnostic trouble codes (including fail-safe codes). (Refer to P.23-35-9)
- (3) Erase the diagnostic trouble codes in order to carry out a road test. (Refer to P.23-35-9.)
- (ATF, TPS, inhibitor switch, manual control cable, etc.) (Refer to P.23-35-37.)
- (5) Carry out a road test. (Refer to P.23-35-2.)

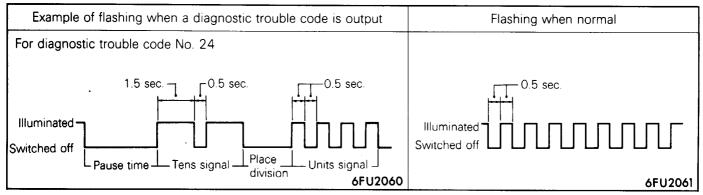
UNDERSTANDING DIAGNOSIS RESULT BY THE OIL TEMPERATURE WARNING LAMP FLASHING

Other diagnostic trouble codes also are output by the flashing of the check warning lamp corresponding to the same code numbers as when using the MUT-II.

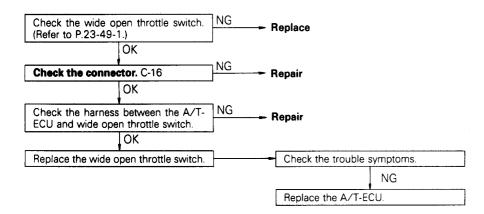
Code No. 22	Wide open throttle switch system	Probable cause
	When the wide open throttle switch is ON despite less than 85% opening of the throttle, Code No. 22 is output.	 Malfunction of wide open throttle switch Malfunction of connector Malfunction of A/T-ECU

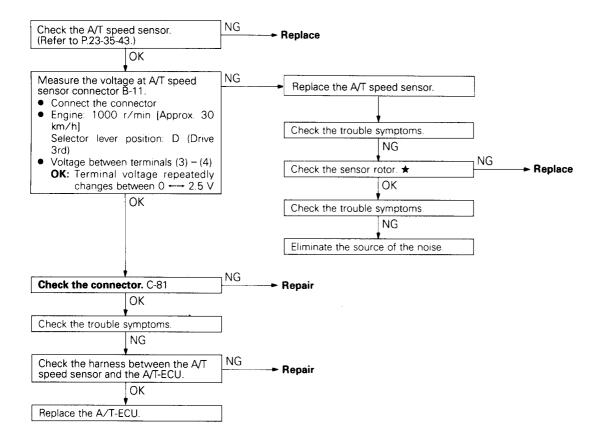
Code No. 32	A/T speed sensor system	Probable cause
fi ir b	the vehicle moves 800 m or more while there is no output rom the A/T speed sensor during the time that four pulses are nput from the vehicle speed sensor, then there is judged to e an open circuit in the A/T speed sensor, and diagnostic rouble code No. 32 is output.	 Malfunction of A/T speed sensor Malfunction of connector Malfunction of sensor rotor Malfunction of A/T-ECU Noise generated

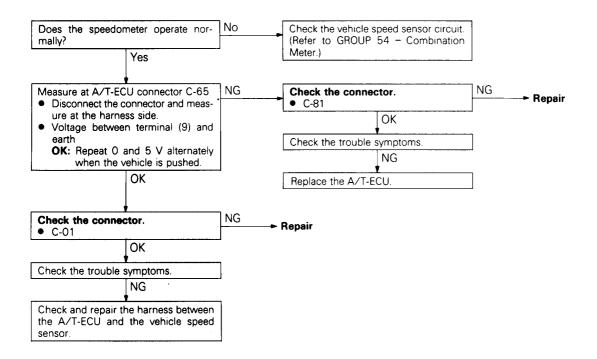
Code No. 38	Vehicle speed sensor system	Probable cause
fr pr pr fr o	the vehicle moves 800 m or more while there is no output om the vehicle speed sensor during the time that 13 ulses (when the transfer control lever is at HIGH) or 25 ulses (when the transfer control lever is at LOW) are input om the A/T speed sensor, then there is judged to be an open circuit in the vehicle speed sensor, and diagnostic ouble code No. 38 is output.	 Malfunction of vehicle speed sensor Malfunction of connector Malfunction of A/T-ECU

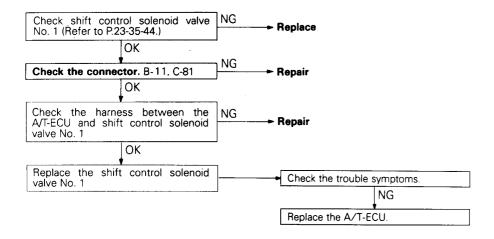
Code No. 41, 42	Shift control solenoid valve No. 1 system	Probable cause
la 1 Va	the resistance value of shift control solenoid valve No. 1 is rge, there is an open circuit in shift control solenoid valve No. and diagnostic trouble code No. 41 is output. If the resistance alue is small, there is a short circuit in shift control solenoid alve No. 1 and diagnostic trouble code No. 42 is output.	 Malfunction of shift solenoid No. 1 Malfunction of connector Malfunction of A/T-ECU

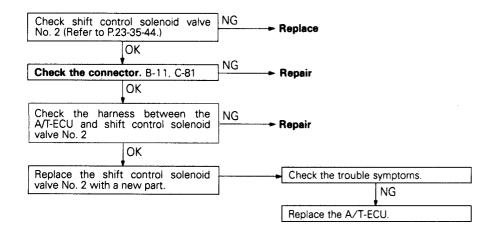
Code No. 43, 44	Shift control solenoid valve No. 2 system	Probable cause
la tio th	the resistance value of shift control solenoid valve No. 2 is arge, there is an open circuit in shift solenoid No. 2 and diagnostic trouble code No. 43 is output. If the resistance value is small, here is a short circuit in shift control solenoid valve No. 2 and iagnostic trouble code No. 44 is output.	 Malfunction of shift control solenoid valve No. 2 Malfunction of connector Malfunction of A/T-ECU

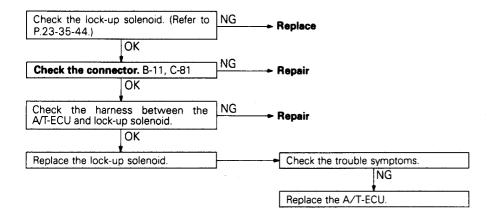
Code No. 47, 48	Lock-up solenoid system	Probable cause
	If the resistance value of the lock-up solenoid is large, there is an open circuit in the lock-up solenoid and diagnostic trouble code No. 47 is output. If the resistance value is small, there is a short circuit in the lock-up solenoid and diagnostic trouble code No. 48 is output.	 Malfunction of lock-up solenoid Malfunction of connector Malfunction of A/T-ECU

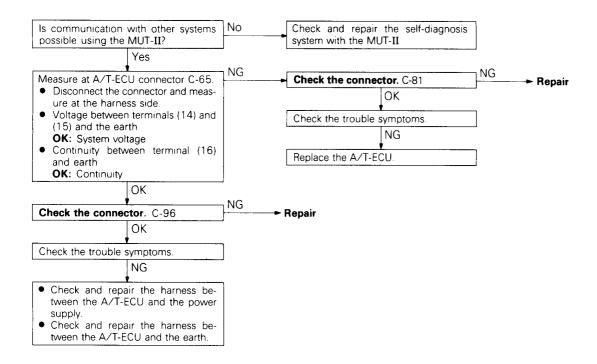
Commu	nication with the MUT-II is not possible	Probable cause
[Comment]	If communication with the MUT-II is not possible, the cause is probably a malfunction in the self-diagnosis system or the A/T-ECU is not functioning.	 Malfunction of self-diagnosis system Malfunction of A/T-ECU power circuit Malfunction of A/T-ECU earth circuit Malfunction of A/T-ECU

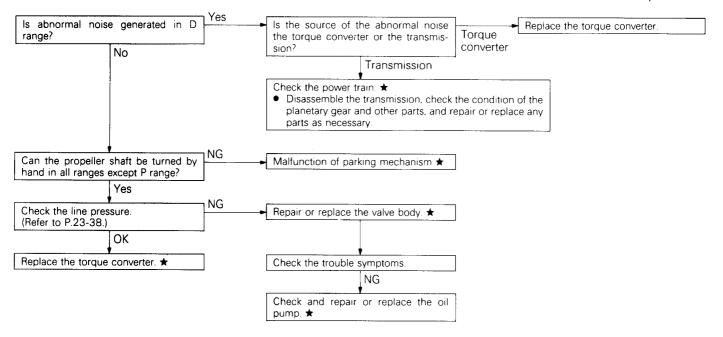
INSPECTION PROCEDURE 2

Does not move forward or reverse		Probable cause	
[Comment]	When the engine is idling, the vehicle does not move forward or back even if the selector lever is shifted from N to D, 2, L or R range. In such cases, the cause is probably abnormal line pressure, or a malfunction of the torque converter, oil pump, parking mechanism or the power train.	 Abnormal line pressure Malfunction of power train Malfunction of oil pump Malfunction of valve body Malfunction of parking mechanism Malfunction of torque converter

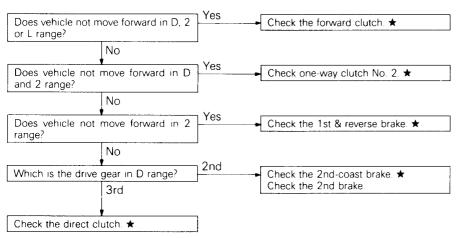
INSPECTION PROCEDURE 3

Does not move forward only		Probable cause
[Comment]	When the engine is idling, the vehicle does not move forward even if the selector lever is shifted from N to D, 2 or L range. In such cases, the cause is probably a malfunction of the clutch or brake.	 Malfunction of forward clutch Malfunction of direct clutch Malfunction of one-way clutch No. 2 Malfunction of 2nd-coast brake Malfunction of 2nd brake Malfunction of 1st & reverse brake

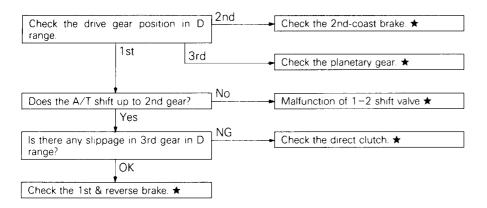
INSPECTION PROCEDURE 4

Does not reverse only		Probable cause
[Comment]	When the engine is idling, the vehicle does not reverse even if the selector lever is shifted from N to R range. In such cases, the cause is probably a malfunction of a clutch, brake or the valve body.	 Malfunction of 2nd-coast brake Malfunction of direct clutch Malfunction of 1st & reverse brake Malfunction of valve body Malfunction of planetary gear

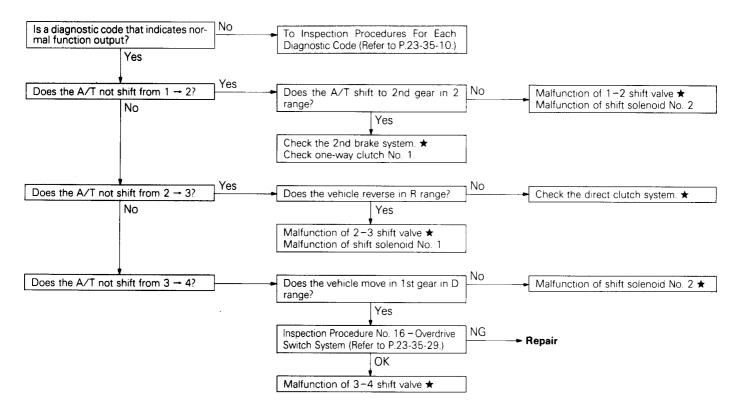
Upshifting does not occur	Probable cause
[Comment] Upshifting does not occur under conditions when upshifting should occur. Check shifting from 1 → 2, 2 → 3 and 3 → 4 respectively.	Shift solenoidA/T-ECUPower train internal parts

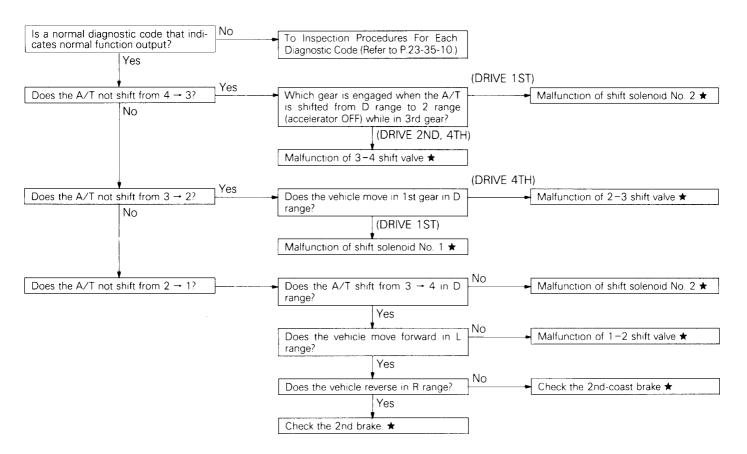
INSPECTION PROCEDURE 6

Downshifting does not occur	Probable cause
[Comment] Downshifting does not occur under conditions when downshifting should occur. Check shifting from 2 → 1, 3 → 2 and 4 → 3 respectively.	Shift solenoidA/T-ECUPower train internal parts

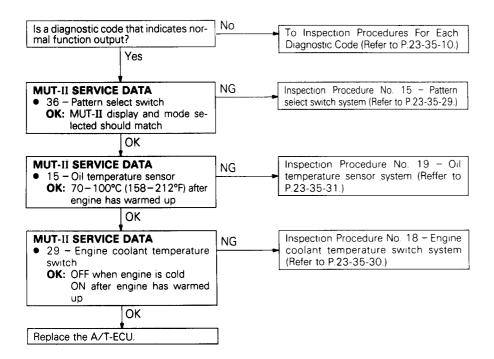
Shifting point abnormality		Probable cause
p	hifting occurs at points which are different from the shift attern. Note that the shift pattern will vary in different modes nd at high oil temperatures.	 Throttle (lever) position sensor A/T speed sensor Oil temperature sensor Pattern selector switch Engine coolant temperature switch A/T-ECU

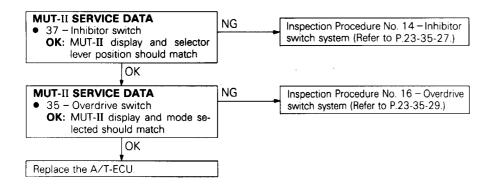
INSPECTION PROCEDURE 8

Upshifting occurs spontaneously	Probable cause
[Comment] Upshifting occurs in ranges where upshifting should not occur when in 2nd gear in L range, 3rd gear in 2 range or 4th gear in D range when OD switch is OFF.	Inhibitor switchOverdrive switchA/T-ECU

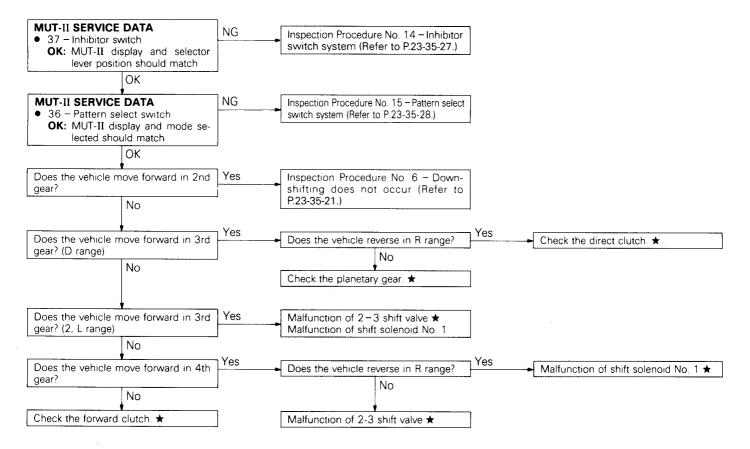
INSPECTION PROCEDURE 9

Incorrect drive gear position		Probable cause	
[Comment]	Vehicle starts off in 2nd, 3rd or 4th gear when in D range. Often occurs when starting off is not smooth.	 Inhibitor switch Pattern select switch Direct clutch Planetary gear Valve body

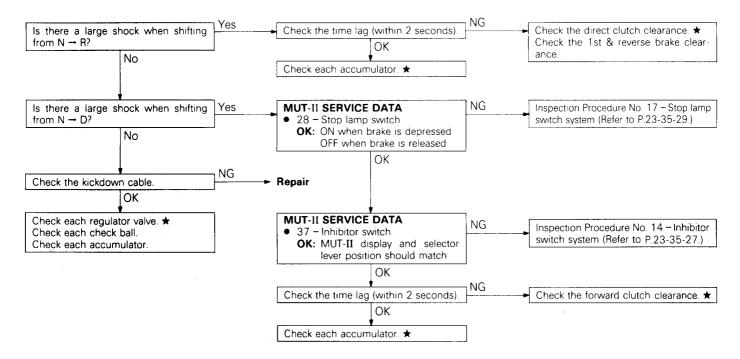
Large shocks		Probable cause	
[Comment]	Shocks accompany shifting from $N \to D$, $N \to R$ and during each upshift and downshift.	 Direct clutch 1st & Rev brake Stop lamp switch Inhibitor switch Forward clutch Valve body

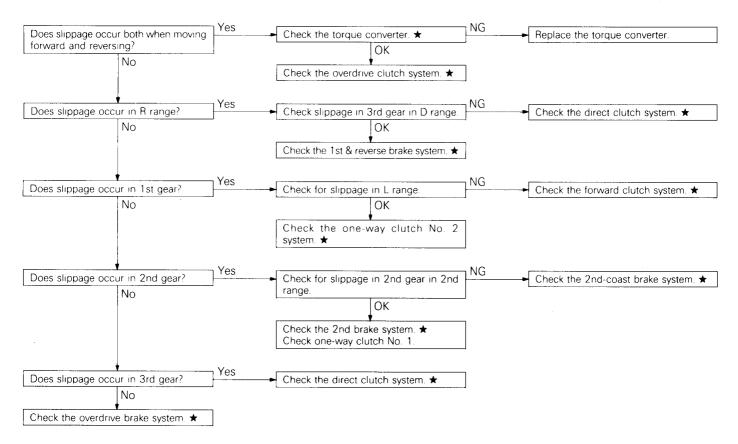
INSPECTION PROCEDURE 11

Slippage (vibration)		Probable cause	
[Comment]	Occurs when a clutch or brake does not fully engage due to low hydraulic pressure or a worn facing. Appears as vibration when the problem is slight.	 Torque converter Direct clutch Forward clutch 2nd-coast brake 2nd brake Overdrive brake

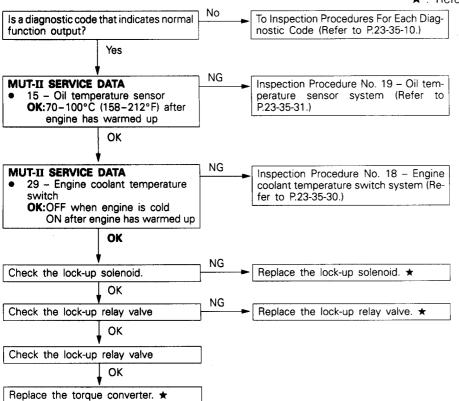
Lockup abnormality	Probable cause
[Comment] When lock-up does not operate even though in the lock-up range, and also when lock-up is operating and the engine is idling but then stalls.	 Torque converter Valve body Oil temperature sensor Engine coolant temperature switch

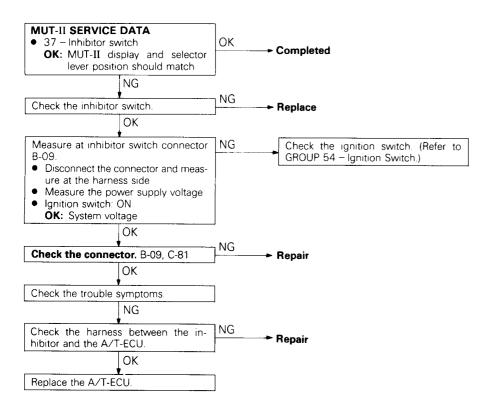
Inhibitor switch system	Probable cause
[Comment] If the engine does not start in P or N range, the cause is probably a problem in the inhibitor switch system.	 Malfunction of inhibitor switch Malfunction of connector Malfunction of A/T-ECU

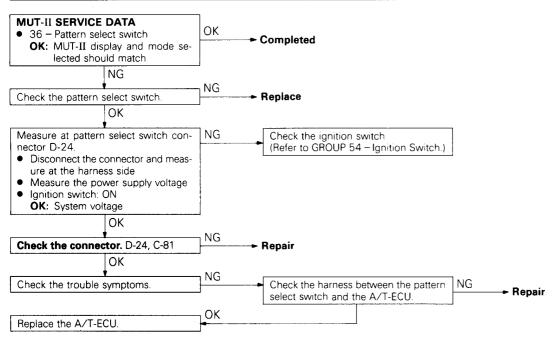
Pattern sele	ect switch system	Probable cause
SW	the shift pattern does not change when the pattern select vitch is operated, the cause is probably a malfunction of the attern select switch.	Malfunction of pattern select switchMalfunction of connectorMalfunction of A/T-ECU

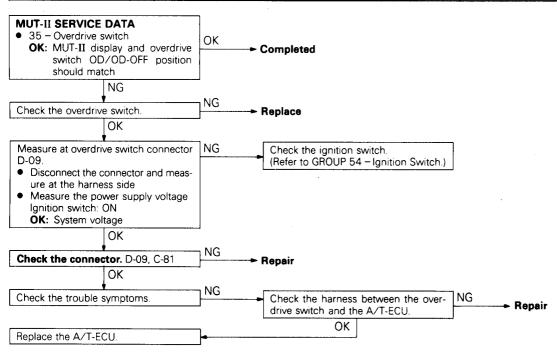
Overdrive switch system		Probable cause
[Comment]	If downshifting does not occur when overdrive is turned off while driving in 4th gear, or if shifting to 4th gear is not possible, the cause is probably a problem in the overdrive switch system.	 Malfunction of overdrive switch Malfunction of connector Malfunction of A/T-ECU

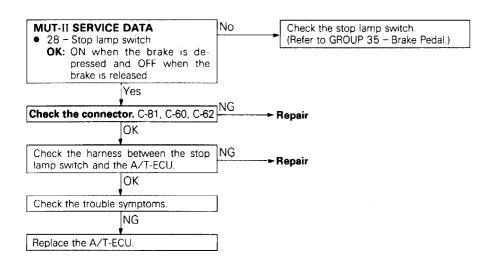
INSPECTION PROCEDURE 17

Stop lamp switch system	Probable cause
[Comment] If large shocks occur during squat control, the cause is probably a problem with the stop lamp switch.	 Malfunction of stop lamp switch Malfunction of connector Malfunction of A/T-ECU

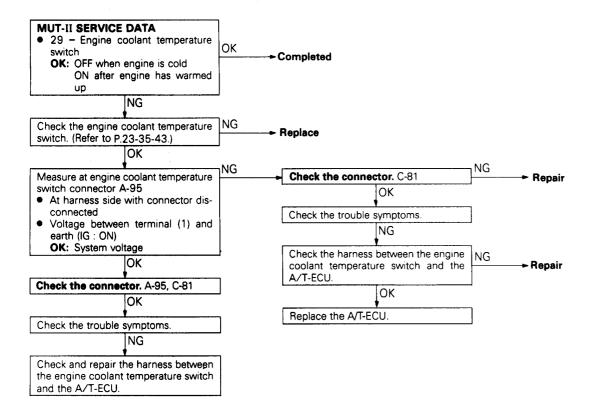
Engine c	oolant temperature switch system	Probable cause		
[Comment]	 The cause is probably a malfunction of the engine coolant tempearture switch: When upshifting to the 4th gear does not occur in D range. (OD switch: ON) When lock-up does not operate even though in the lock-up range. When there is insufficient output while the engine is cold. 	 Malfunction of engine coolant temperature switch Malfunction of connector Malfunction of A/T-ECU

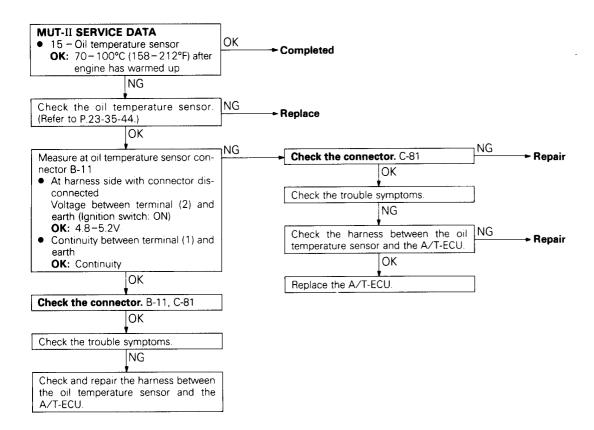
Oil temp	perature sensor system	Probable cause
[Comment]	If the oil temperature warning lamp remains illuminated, the cause is probably a problem with the oil temperature sensor.	 Malfunction of oil temperature sensor Malfunction of connector Malfunction of A/T-ECU

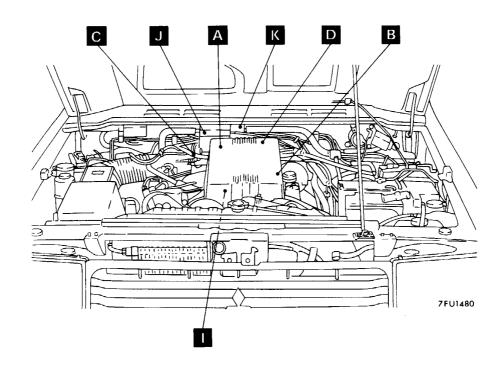
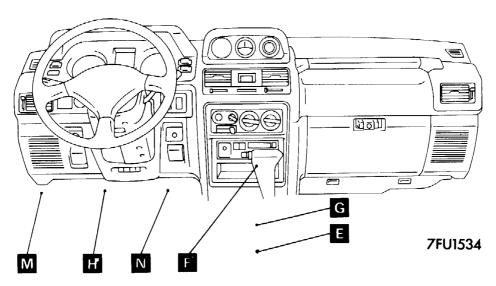
ELC-4A/T CONTROL COMPONENT LOCATION < V4AW3>

Name	Symbol	Name	Symbol
Throttle position sensor <3000-24V, 3500>	Α	Stop lamp switch	Н
Lever position sensor <2800D>	В	Engine coolant temperature switch	ı
Inhibitor switch	С	Oil temperature sensor	J
A/T-speed sensor	D	Solenoid valves	K
Vehicle-speed sensor	E	A/T-ECU	L
Overdrive switch	F	Diagnosis connector	М
Pattern select switch	G	Wide open throttle switch	N

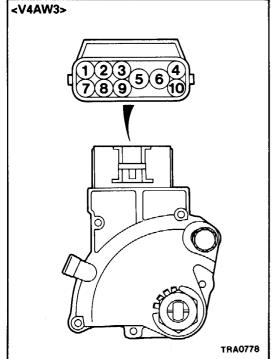
INHIBITOR SWITCH CHECK <V4AW2>

Item	Terminal No.								
	1	2	3	4	5	6	7	9	12
Р						0-	0-	0	-0
R					0-			-0	
N				0-			0-	0	0
D			0-					0	
2	$\overline{\bigcirc}$							0	
L		\circ						-0

Item	Terminal No.								
	1	2	3	5	6	7	8	9	10
Р	\bigcirc			0-					-0
R	\Diamond							0	
N	0			0-	0	-0			
D	0						0		
2	0		0						
L	\circ	- 0

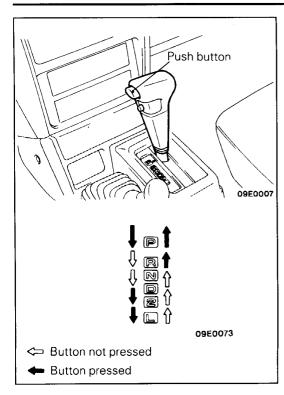
SELECTOR LEVER OPERATION CHECK E23FOAB

- Shift selector lever to each range and check that lever moves smoothly and is controlled. Check that position indicator is correct.
- 2. Check to be sure the selector lever can be shifted to each position (by button operation as shown in the illustration).
- 3. Start the engine and check if the vehicle moves forward when the selector lever is shifted from N to D, and moves backward when shifted to R.
- 4. When the shift lever malfunctions, adjust control cable and selector lever sleeve. Check for worn shift lever assembly sliding parts.

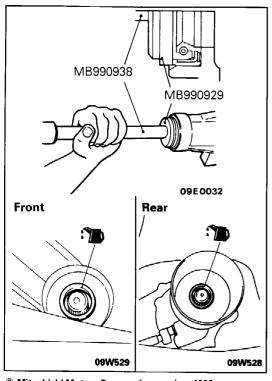
TRANSFER OIL SEALS REPLACEMENT

- E22FAAF
- 1. Disconnect the propeller shaft from the transfer. (Refer to GROUP 25-Propeller Shaft.)
- 2. Using a flat-tip (-) screwdriver, remove the oil seal.
- 3. Using the special tool, tap the transfer oil seal into the transfer. Note in illustration the direction of installation of transfer oil seal.
- 4. Apply a coating of the transmission oil to the lip of the oil seal.

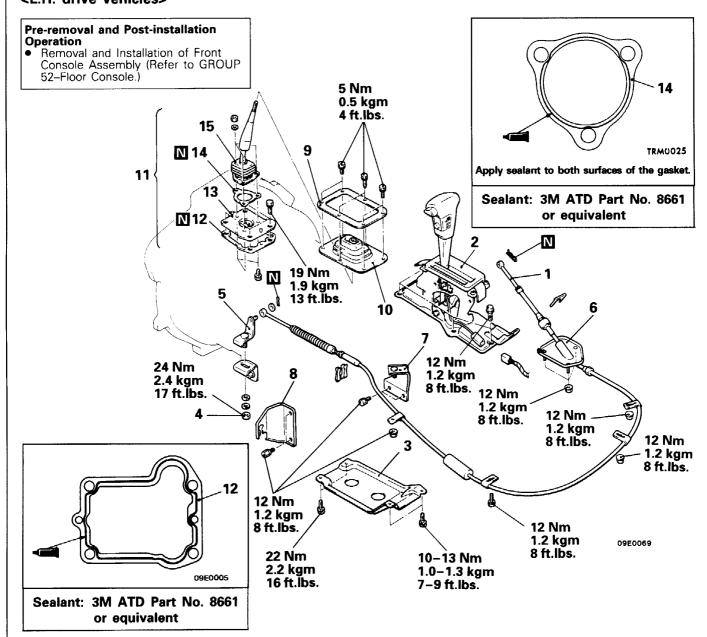
<L.H. drive vehicles>

Selector lever assembly removal steps

- 1. Connection for transmission control cable assembly (selector lever assembly side)
 - 2. Selector lever assembly

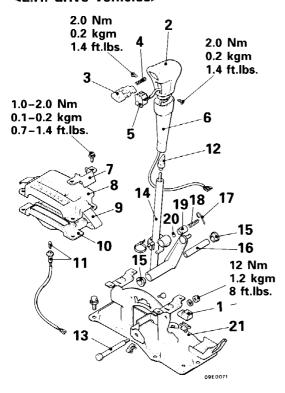
<L.H. drive vehicles>

- 1. Overdrive switch/position lamp switch connector case
- Selector knob
 - 3. Push button
 - 4. Spring
- 5. Overdrive switch
 - 6. Knob cover
 - 7. Guide
 - 8. Upper panel
 - 9. Slider
 - 10. Lower panel
 - 11. Position indicator lamp assembly
 - 12. Sleeve
 - 13. Bolt
 - 14. Selector lever assembly15. Bushing

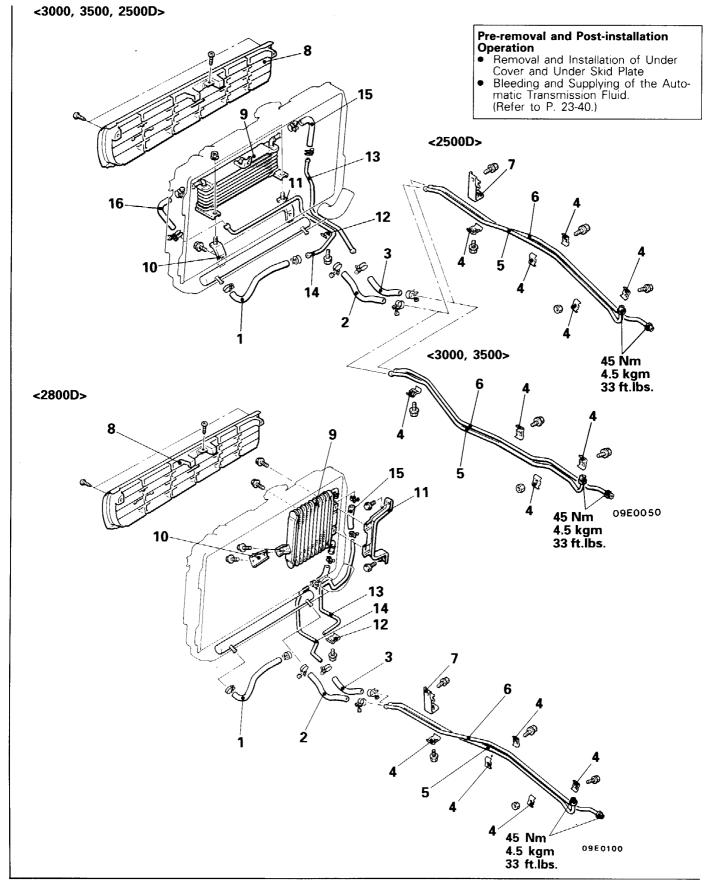
REMOVAL AND INSTALLATION

- ▶ 1. Hose A
- ◆◆ 2. Hose B
- → 4 3. Hose C

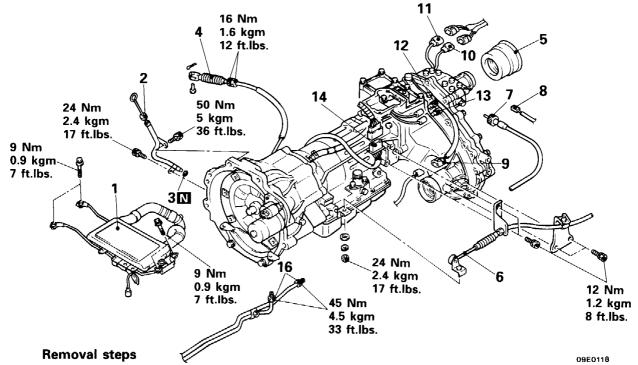
- 1. Intercooler
- 2. Oil filler pipe
- 3. O-rina
- ◆ 4. Connection for throttle control cable
 - 5. Dust seal guard
- ◆ 6. Connection for transmission control cable
 - Connection for speedometer cable
 Vehicles built up to October, 1993>
 - 8. Speed sensor connector
 -

Vehicles built from November, 1993>
 - 9. HI/LO detection switch connector
 - 10. 4WD operation detection switch connector
 - 11. Center diffenential lock operation detection switch connector
 - 12. Center differential lock detection switch connector
 - 13. 2WD/4WD detection switch connector
 - 14. Inhibitor switch connector
 - 16. Connection for oil cooler pipe

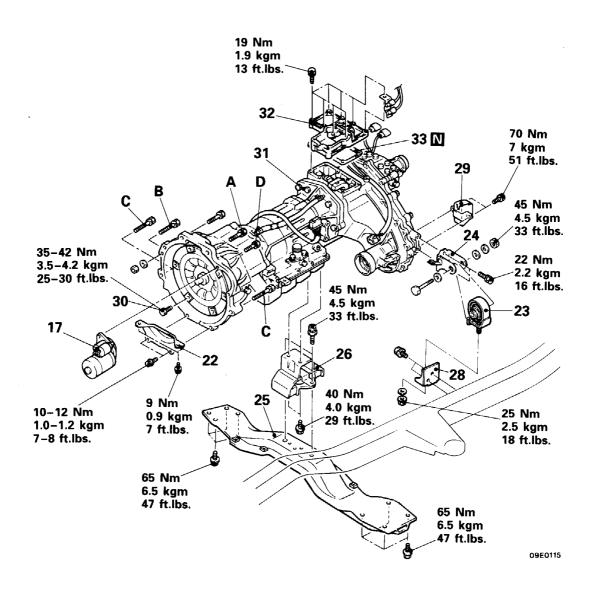
- 17. Starter motor
- 22. Bell housing cover
- 23. Transfer roll stopper
- 24. Transfer mounting bracket
- 25. No. 2 crossmember 26. Engine mount rear insulator
- 28. Transfer case protector bracket
- 29. Mass damper
- 30. Torque converter connecting bolt
- 31. Transmission and transfer assembly
 - 32. Control housing
 - 33. Gasket

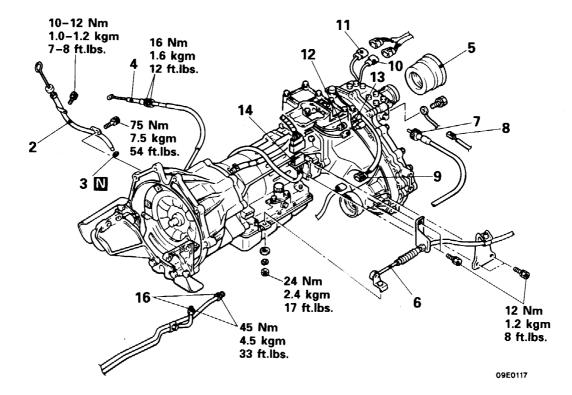
- 2. Oil filler pipe
- 3. O-ring
- 4. Connection for throttle control cable
 - 5. Dust seat guard
- 6. Connection for transmission control cable
 - 7. Connection for speedometer cable <Vehicles built up to October, 1993>
 - 8. Speed sensor connector
 - <Vehicles built from November, 1993>
 - 9. HI/LO detection switch connector
 - 10. 4WD operation detection switch connector
 - 11. Center differential lock operation detection switch connector
 - 12. Center differential lock detection switch connector
 - 13. 2WD/4WD detection switch connector
 - 14. Inhibitor switch connector
 - 16. Connection for oil cooler pipe

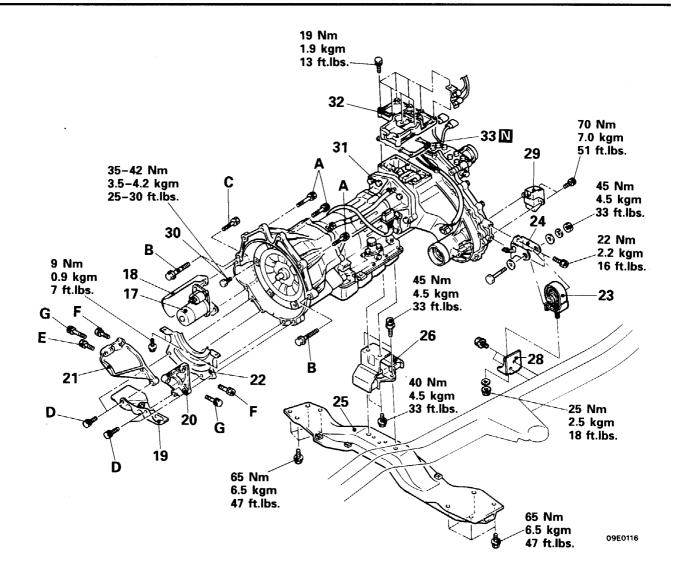
- 17. Starter motor
- 18. Starter cover
- 19. Heat protector
- 20. Transmission stay (L.H.) 21. Transmission stay (R.H.)
- 22. Bell housing cover
- 23. Transmission roll stopper
- 24. Transfer mounting bracket
- 25. No. 2 crossmember
- 26. Engine mount rear insulator
- 28. Transfer case protector bracket
- 29. Mass damper
- 30. Torque converter connecting bolt
- 31. Transmission and transfer assembly
 - 32. Control housing
 - 33. Gasket

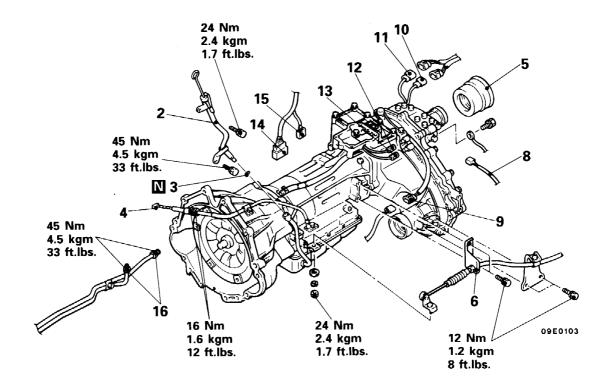
- 2. Oil filler pipe
- 3. O-ring
- 4. Connection for throttle control cable
- 5. Dust seal guard
- 6. Connection for transmission control cable
- 8. Speed sensor connector
- 9. HI/LO detection switch connector
- 10. 4WD operation detection switch connector
- 11. Center differential lock operation detection switch connector
- 12. Center differential lock detection switch connector
- 13. 2WD/4WD detection switch connector
- 14. Inhibitor switch connector
- 15. Solenoid valve connector
- 16. Connection for oil cooler pipe

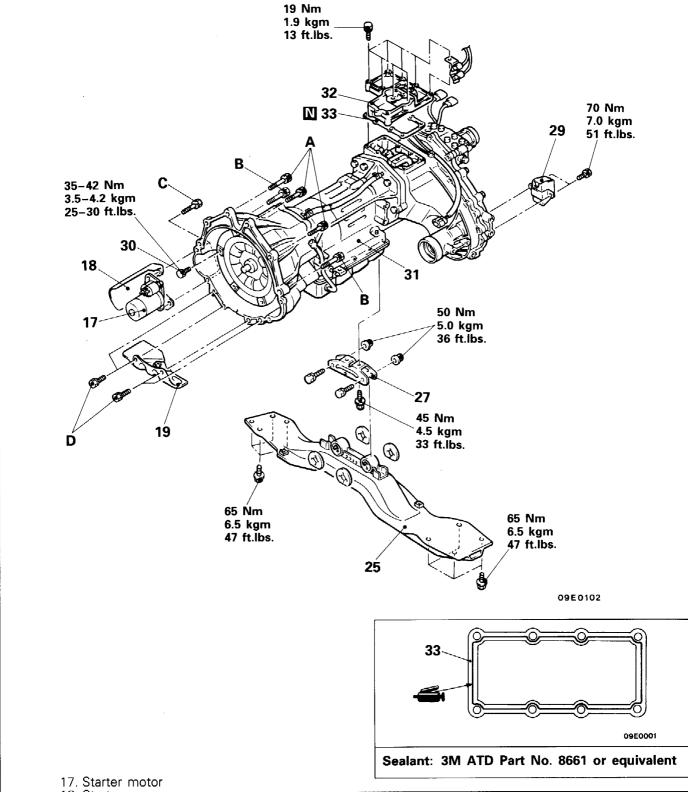
- 18. Starter cover
- 19. Heat protector 25. No. 2 crossmember
- 27. Engine rear mount bracket
- 29. Mass damper
- 30. Torque converter connecting bolt 31. Transmission and transfer assembly
- 32. Control housing
- 33. Gasket

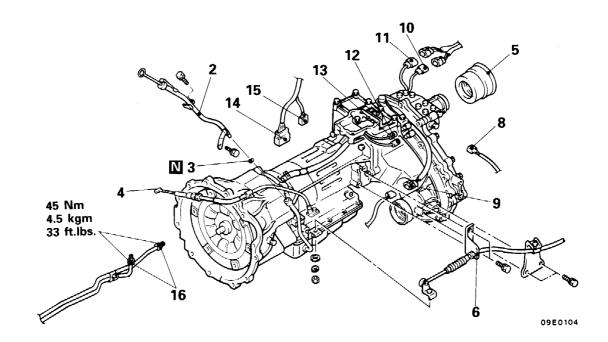
- 2. Oil filler pipe
- 3. O-ring
- 4. Connection for throttle control cable
- 5. Dust seat guard
- 6. Connection for transmission control cable
- 8. Speed sensor connector
- 9. HI/LO detection switch connector
- 10. 4WD operation detection switch connector
- 11. Center differential lock operation detection switch connector
- 12. Center differential lock detection switch connector
- 13. 2WD/4WD detection switch connector
- 14. Inhibitor switch connector
- 15. Solenoid valve connector
- 16. Connection for oil cooler pipe
